Manhole Inspection Summary

Manhole # S29GG_022MH

Location Address: **1412 MASON ST**

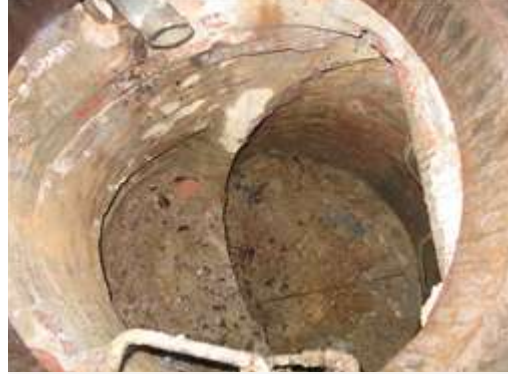
Top View

Corroded steps. Channel debris.

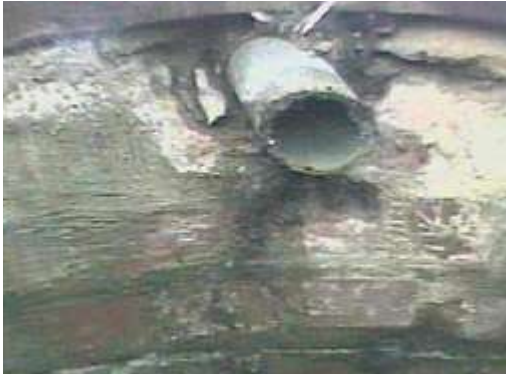
Comments **There is a possible illicit connection in this MH.**

Possible illicit connection.

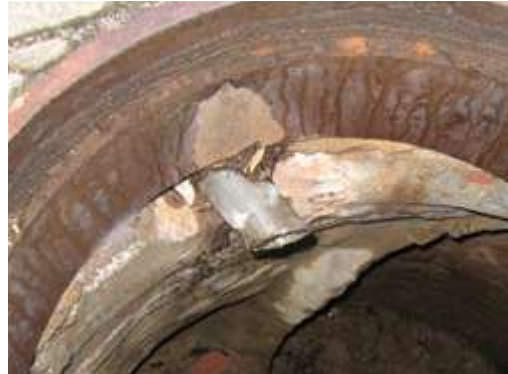
Defect

Condition: ☐ Sound ☐ Cracked ☐ Root Intrusion ☐ Loose Brick ☒ **Deteriorated**

Infiltration: ☐ None ☒ **Joint** ☐ Cracks ☒ **Mortar** ☐ Roots ☒ **Wall**

Infiltration: ☐ None ☐ Joint ☐ Cracks ☒ **Mortar** ☐ Roots ☒ **Wall**

Adjustment deterioration and infiltration.
Barrel infiltration.

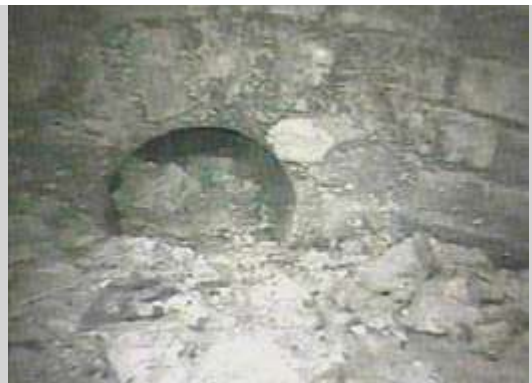
8 in. Circular Gravity Sewer

Pipe Out @ 12 O'Clock

Deposits: ☐ None ☒ **Mud** ☐ Sludge ☒ **Debris** ☐ Grease

Silt Depth: **6** (in.)

Deposits Extent: **Heavy**

Infiltration: **Evidence**
